# COLFAX FLUID HANDLING RELIABILITY SERVICES DELIVERS BIG FOR OFFSHORE

## FAST, EFFICIENT PRECOMMISSIONING SERVICES KEY TO MEETING TIMELINE FOR TENSION LEG PLATFORM

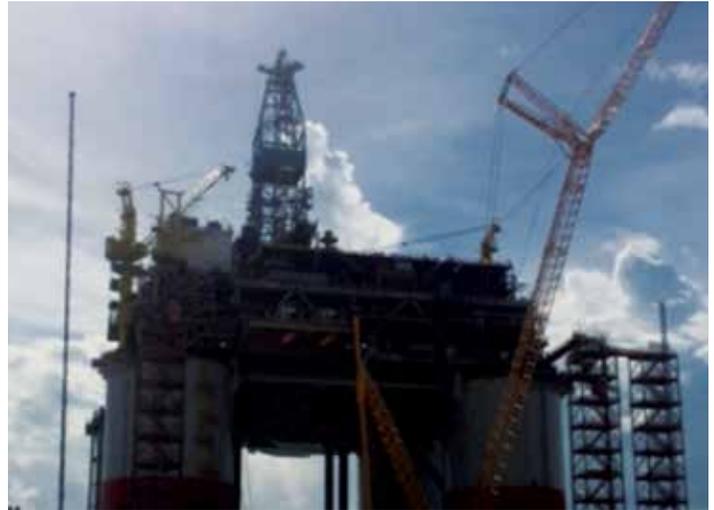
*TLP Under Construction*

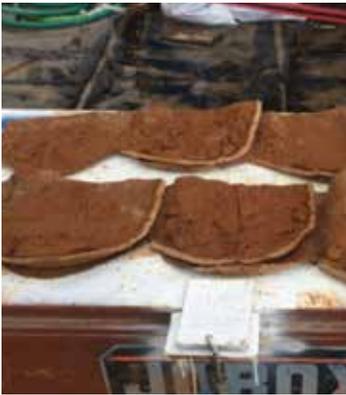
*BEFORE: Initial Flush Filtration Bag Inspection on Heat Medium Piping System*

Each piping system was chemically cleaned to remove all corrosion. A high velocity oil flush was then performed to remove particulates and meet mutually agreed upon cleanliness criteria. The man basket HPUs and tensioner HPUs in the well bay were chemically cleaned, particulate flushed, air blown, and high velocity oil flushed. The high velocity oil flushes were performed to NAS 5 standards and the water flush was done by visual bag inspection on 25 micron bags.

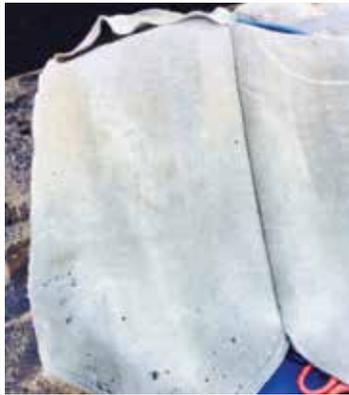
*AFTER: Passing Bag on Heat Medium System*

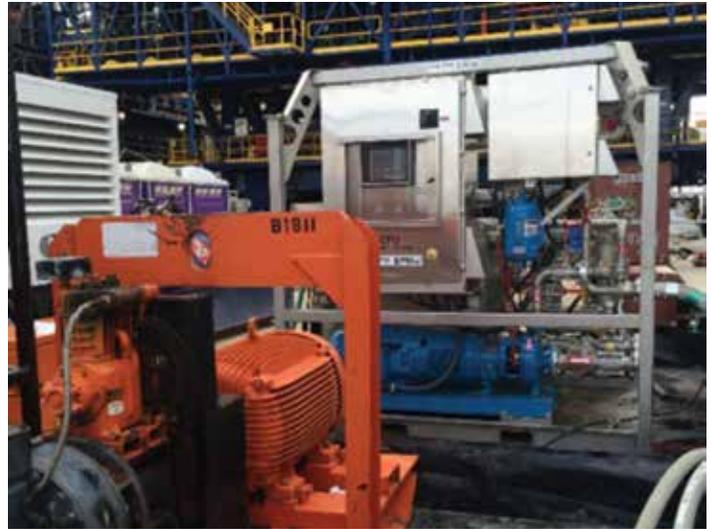
*ICU 150 with 6 x 6 Centrifugal Pump on Deck*
